PROPERTY CONDITION ASSESSMENT

SEA MIST OCEANFRONT RESORT
1200 SOUTH OCEAN BLVD
MYRTLE BEACH, SOUTH CAROLINA

ECS PROJECT NO. 48:1539

AUGUST 24, 2018

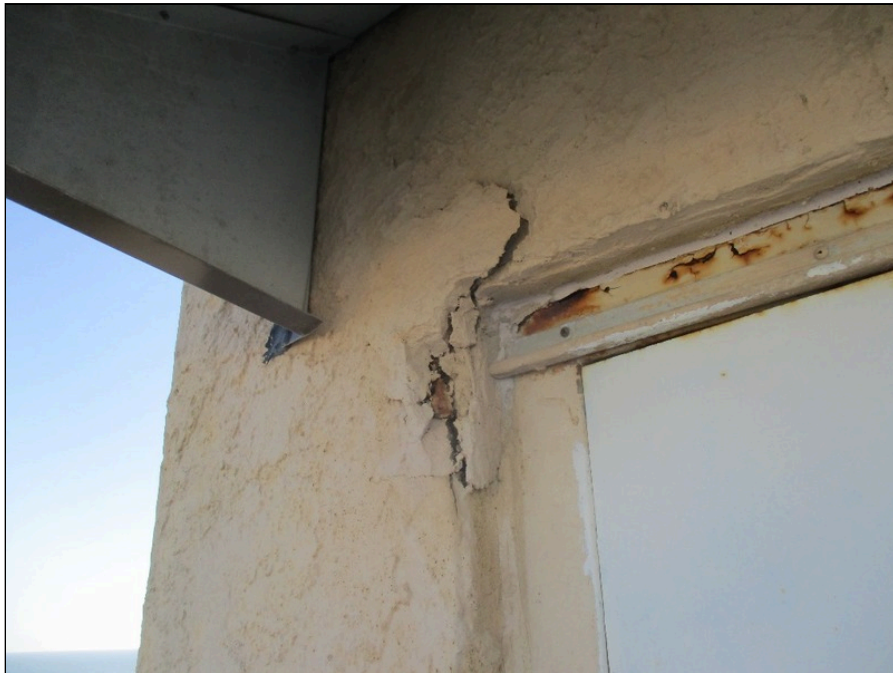
8 - Cracking distress at doorway

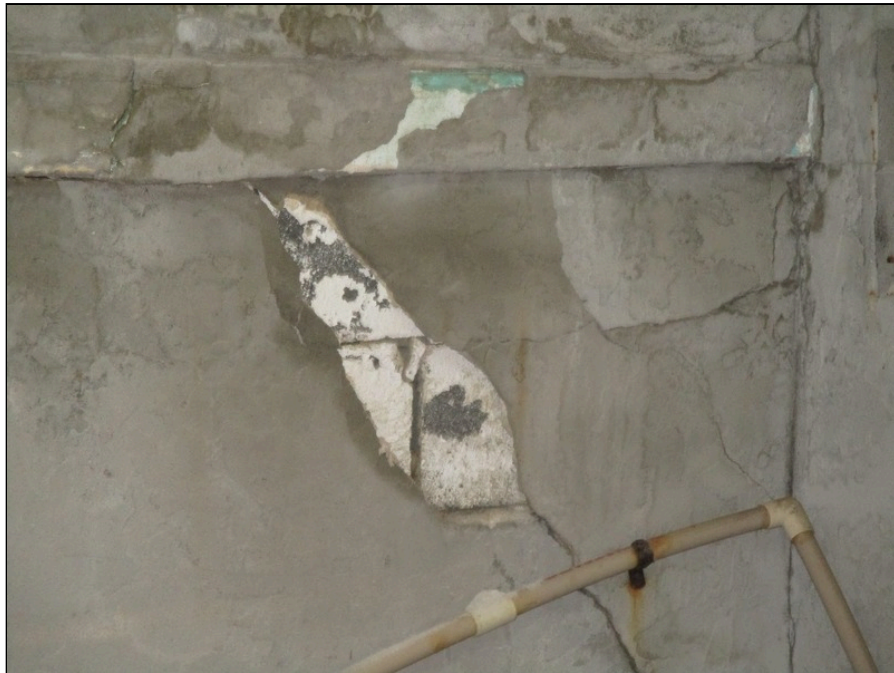
10 - Cracking in pool room exterior wall

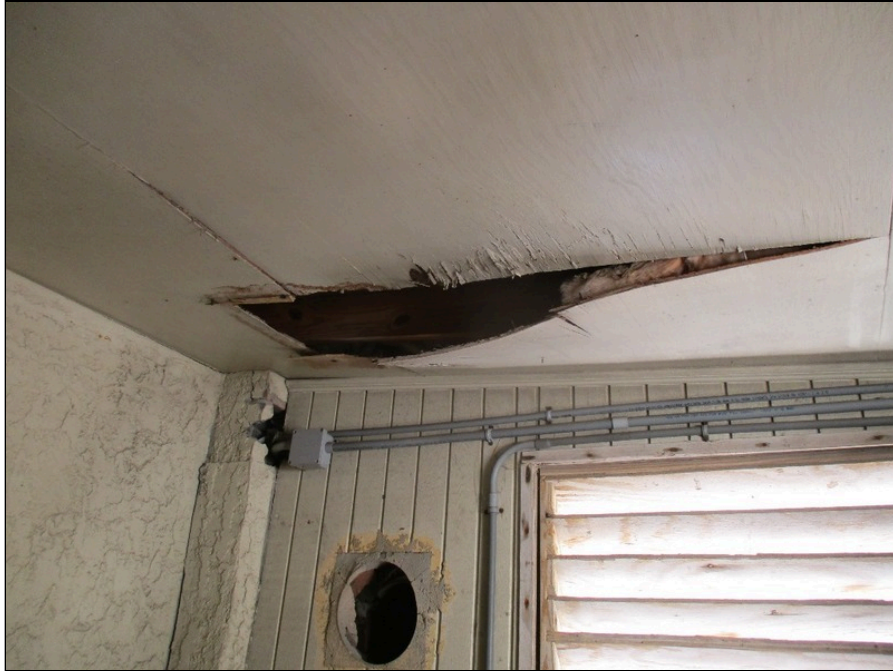
11 - Pool room ceiling deterioration

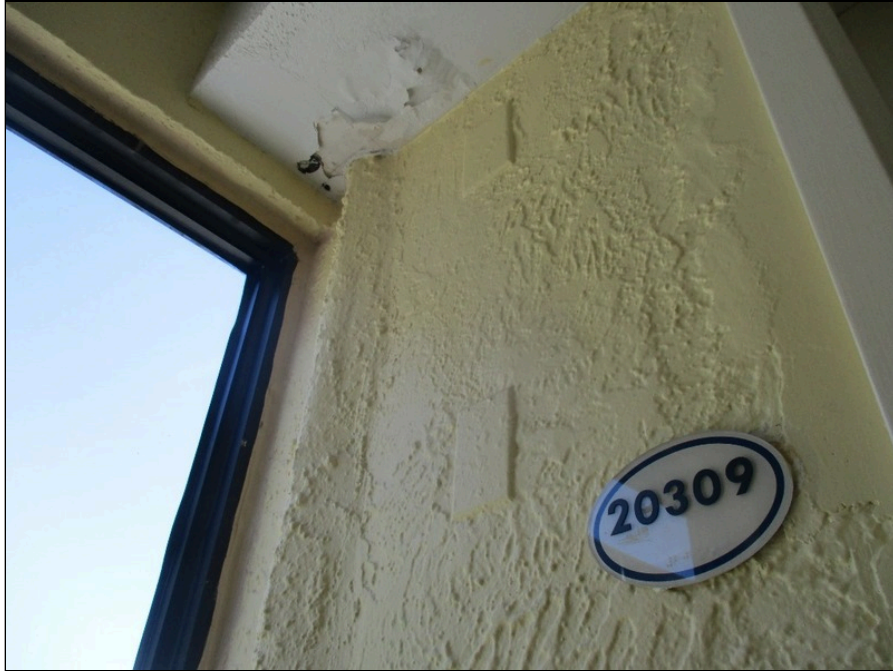
13 - Isolated moisture infiltration at hallway exterior window

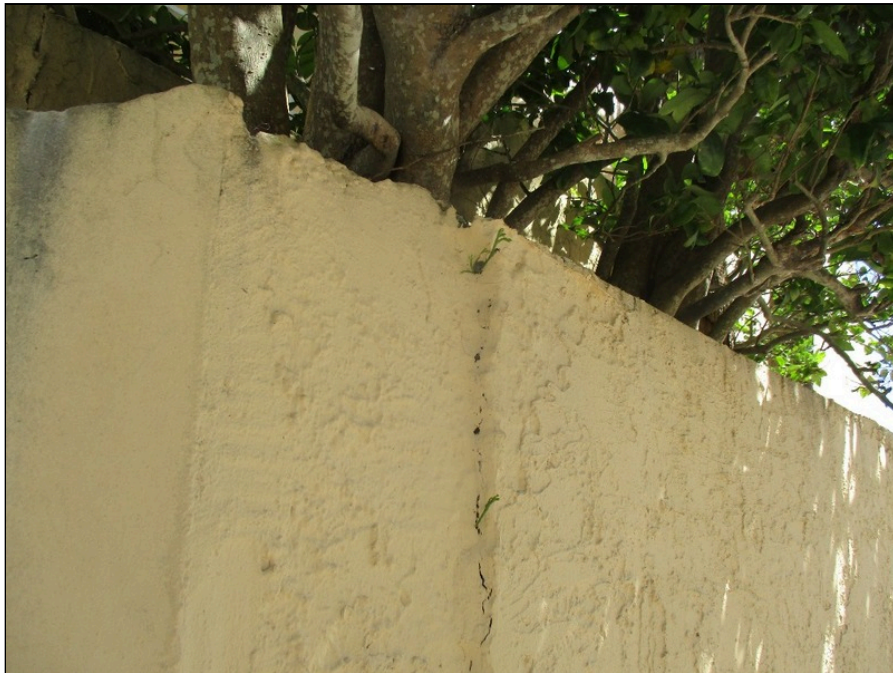
The Property has concrete retaining walls and short walls along the south and eastern perimeter, and ECS observed isolated cracking and displacement within the walls. We recommend repairs to prevent further degradation.

14 - Cracked retaining wall south of Tides

Cost Recommendation	EUL	EFF AGE	RUL	Year	Cost
CONCRETE WALL CRACKING REPAIRS	-	-	-	1	\$3,000
Total					\$3,000

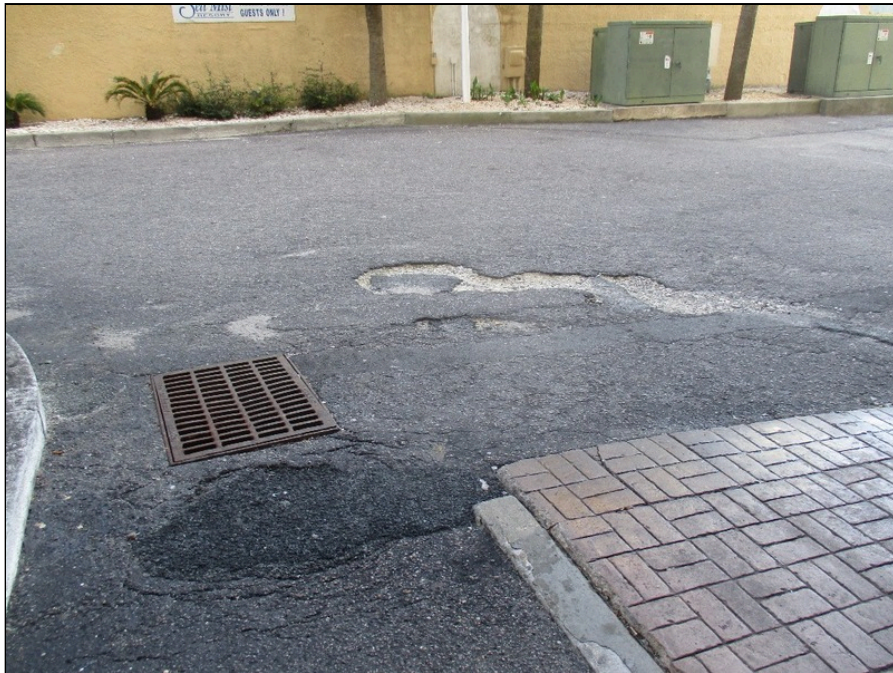
Longitudinal cracking was observed at the accessible parking areas of the pavement. No information giving the age of the pavement or the last overlay was available. The parking area contained 11 spaces and 7 accessible parking spaces. Additional parking is available on 13th Avenue South directly adjacent to the buildings. Some minor cracking was observed in concrete curbing, likely due to normal shrinkage and thermal expansion.

16 - isolated pavement distress, drop inlet

ECS recommends allocating for an asphalt overlay over the term and sealing of linear cracks as they

form. Routine maintenance is considered adequate for addressing isolated cracking in concrete curbs and repairing potential trip hazards.

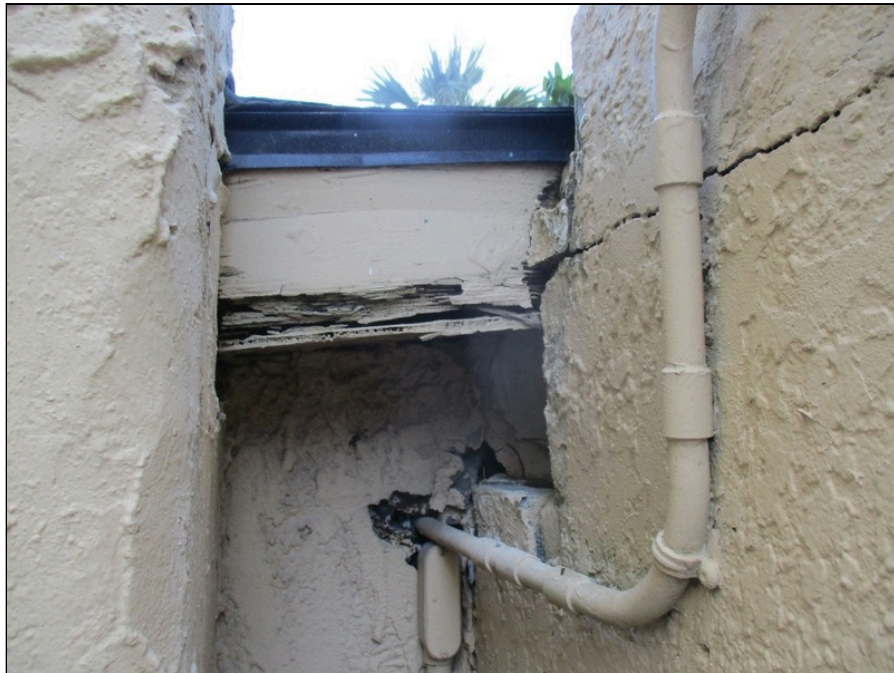
The buildings incorporate an indoor spa, indoor/outdoor lazy river, and an indoor kiddie pool below the Driftwood building. The pool equipment room is located north of the pool area in an enclosed building that appeared to be in fair condition. Triton II filters were observed and are in good to fair condition. Blower motors are utilized for the spas. The outdoor deck adjacent to the Driftwood building was overlain with brick pavers. These pavers appeared to be in fair overall condition, with areas of isolated cracking and mortar joint deterioration. We recommend allocations for repairs.

18 - Pool equipment building exterior deterioration

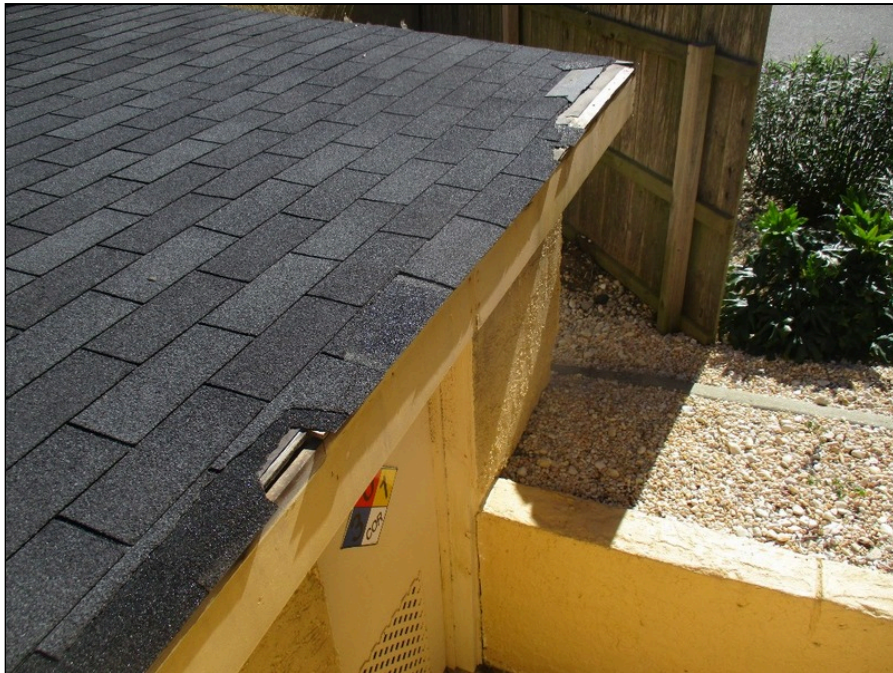
24 - Pool equipment room roof deterioration

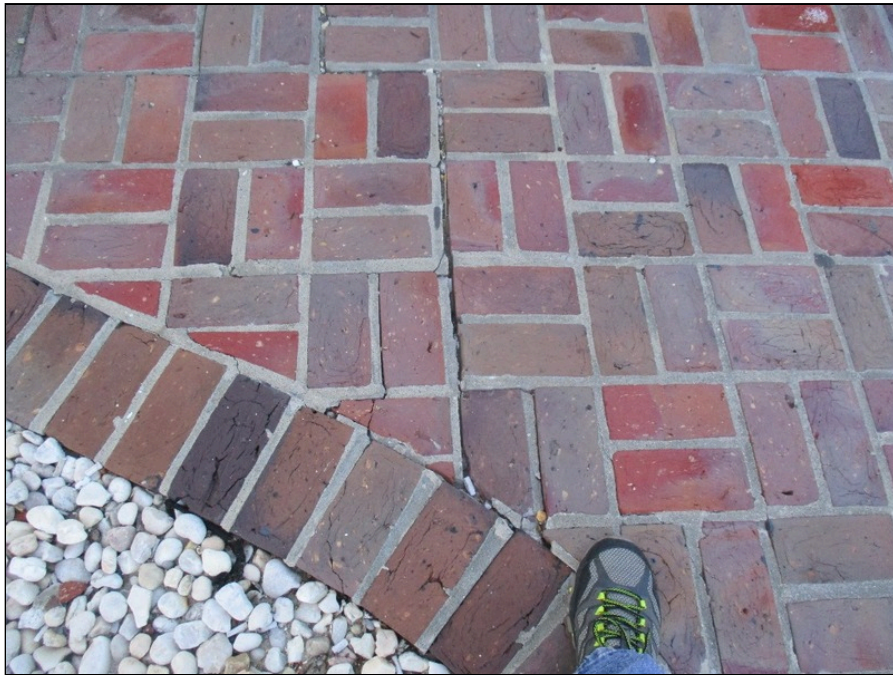
52 - Pool deck brick cracking

Cost Recommendation	EUL	EFF AGE	RUL	Year	Cost
POOL DECK REPAIRS	-	-	-	6	\$12,500
				16	\$12,500
Total					\$233,000

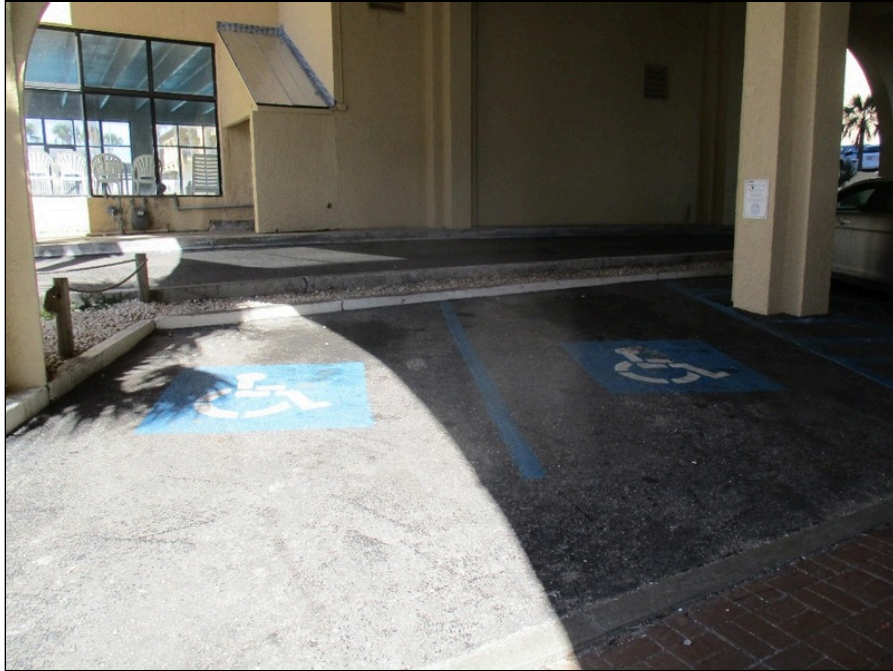
55 - Accessible parking in main service drive - no signage

Item	Quantity	Unit	Unit Cost	Replacement Percent	Immediate Total
3.8.1 ADA - Access to the Building					
PROVIDE COMPLIANT SIGNAGE AND ACCESS AISLES	1	LS	\$4,000.00	100%	\$4,000
Total Repair Cost					\$4,000.00
